# Municipality Case History

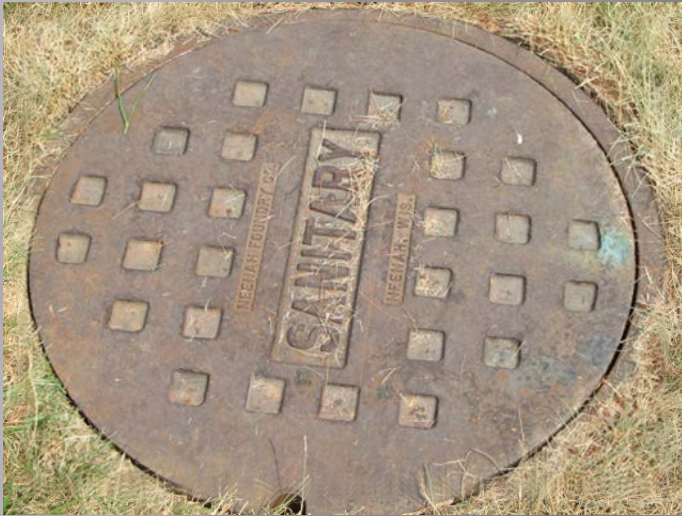
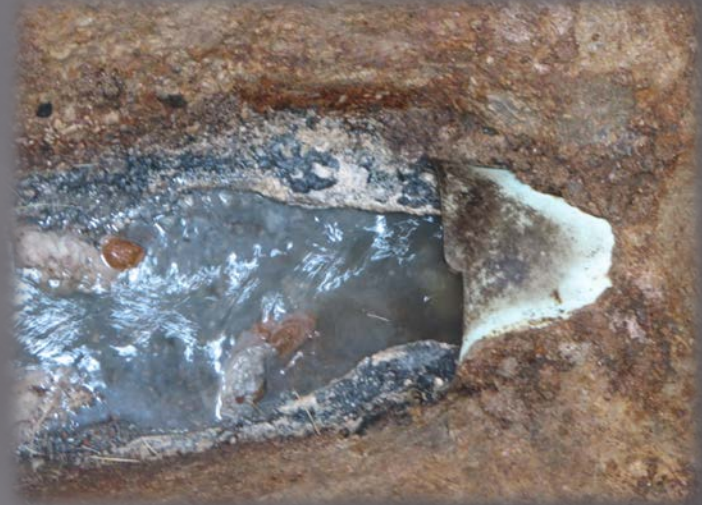
Grease in Manhole outside Chinese restaurant  
prior to bioaugmentation

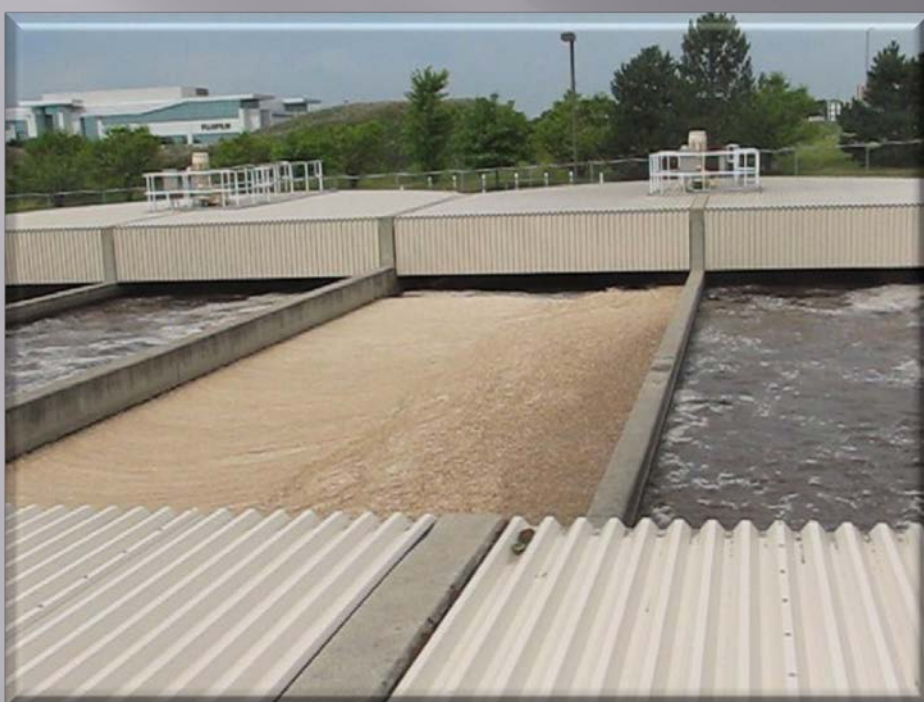
Oxidation ditch  
7-7-11  
Before  
Bioaugmentation

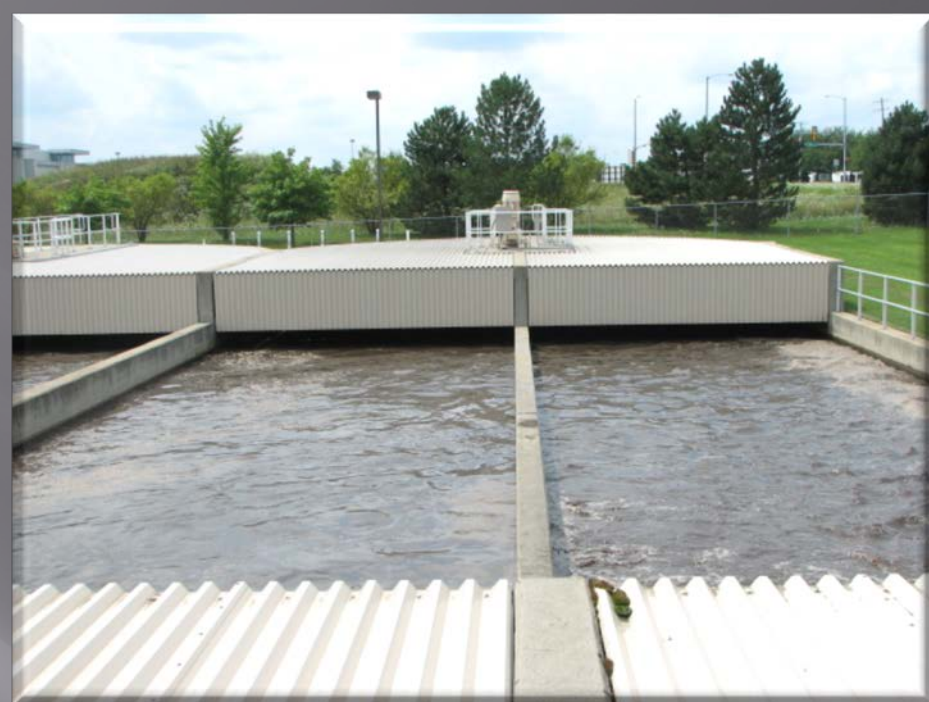
Oxidation ditch  
8-8-11  
After  
Bioaugmentation

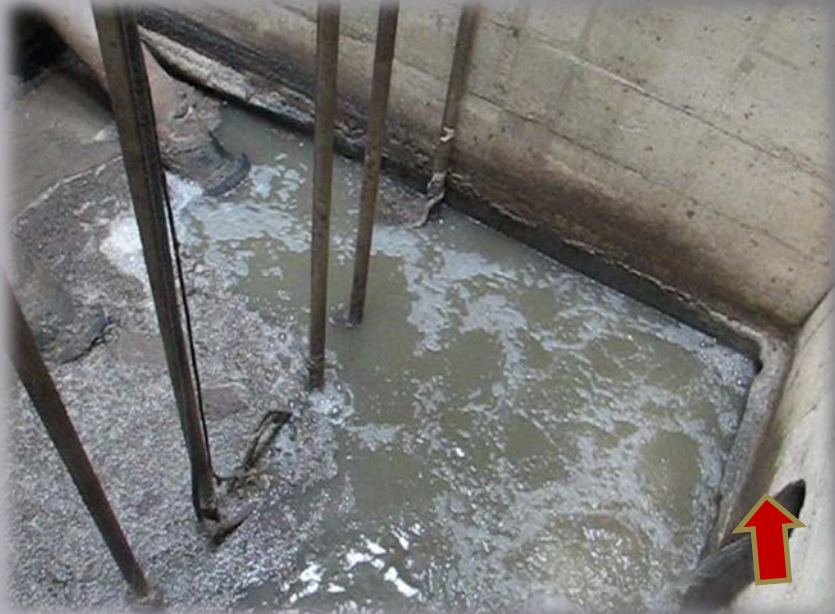
WETWELL

Notice the grease shelf along the walls 7-7-11

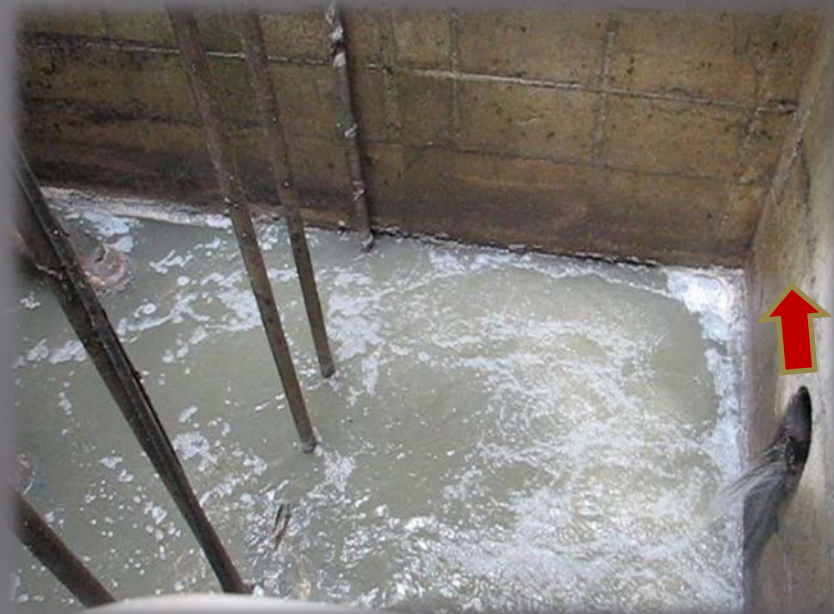
8-8-11 after short term use of bioaugmentation

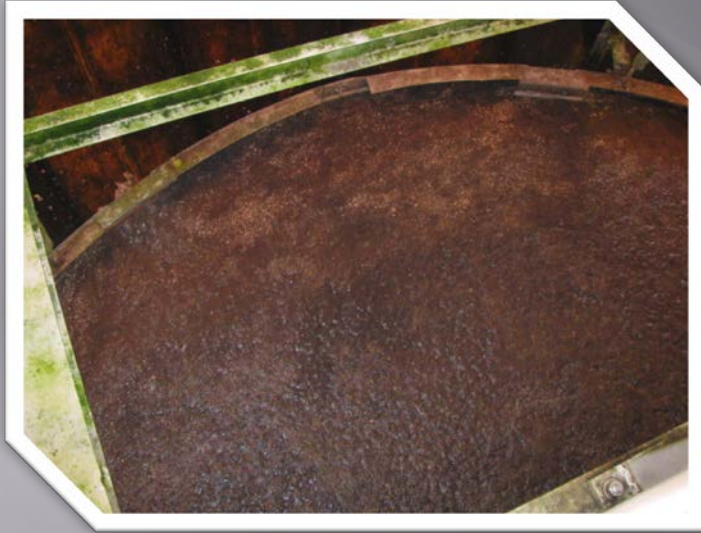
7-7-11 Before Bioaugmentation

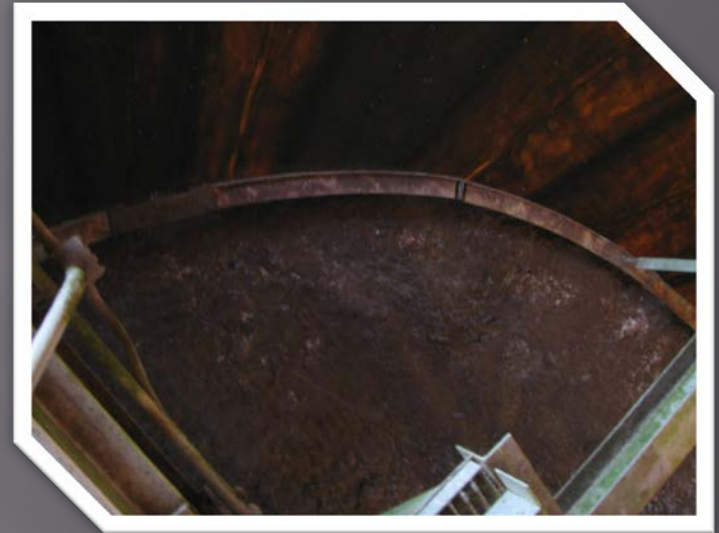
8-8-11 After Bioaugmentation

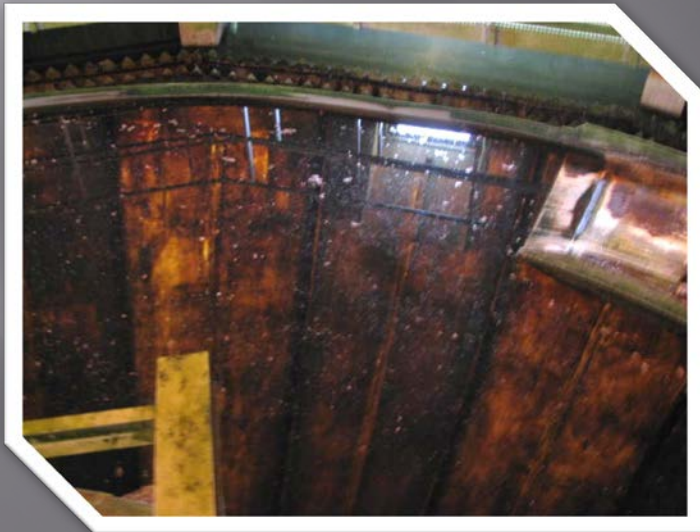
High levels of gassing and ashing

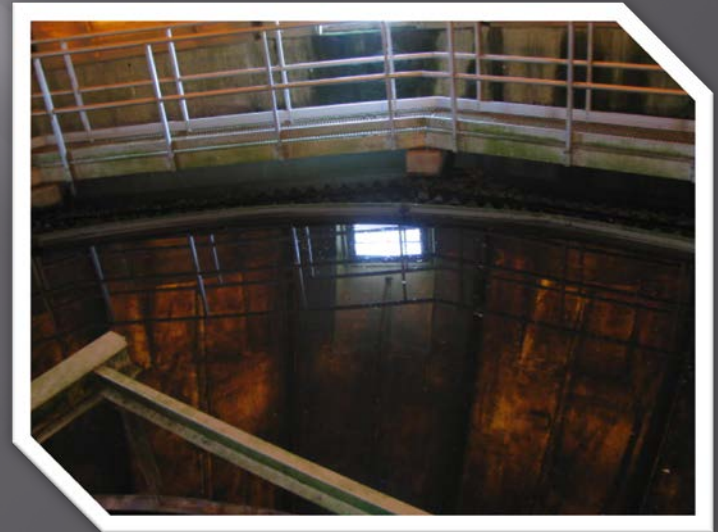
Lower levels of ashing and gassing but still scum and solids in centerwell

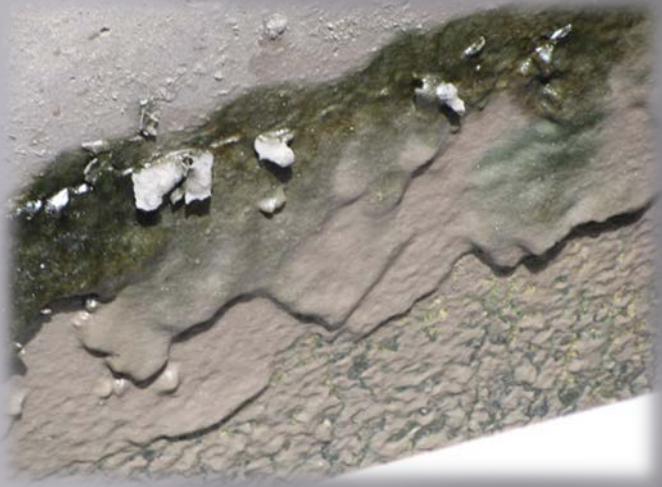
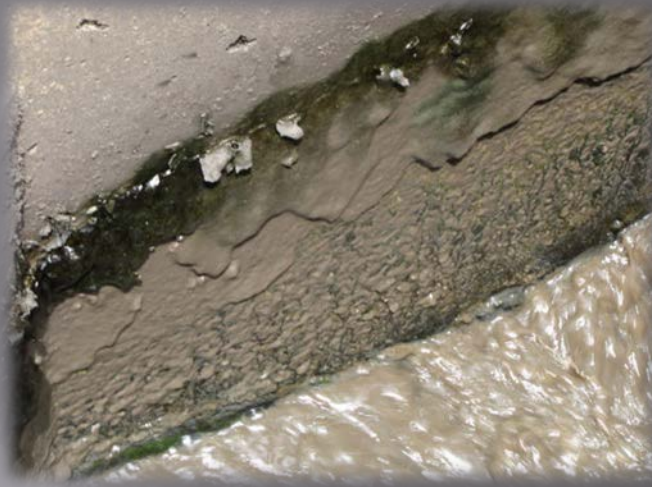
Inlet channel does have scum on sidewall build up that can slough off and add to TSS

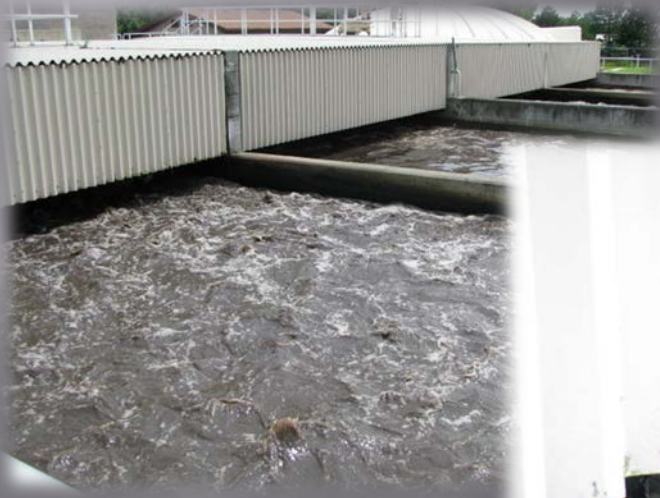
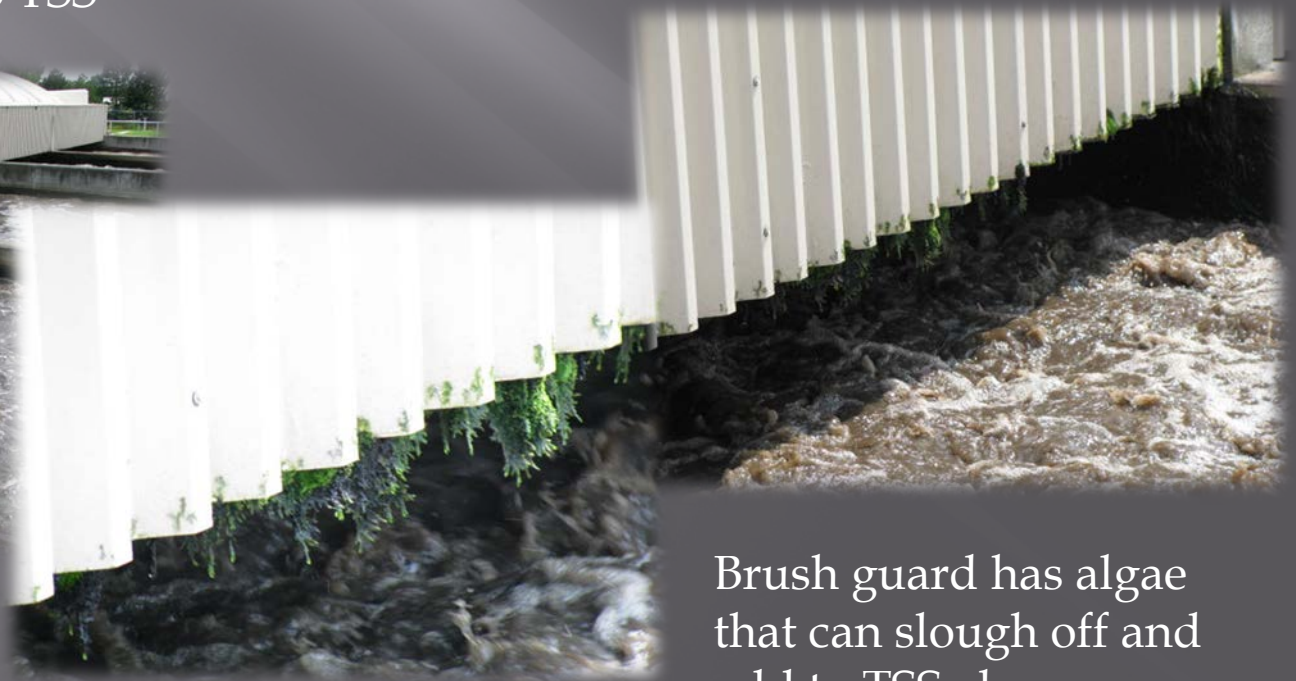
Brush guard has algae that can slough off and add to TSS also

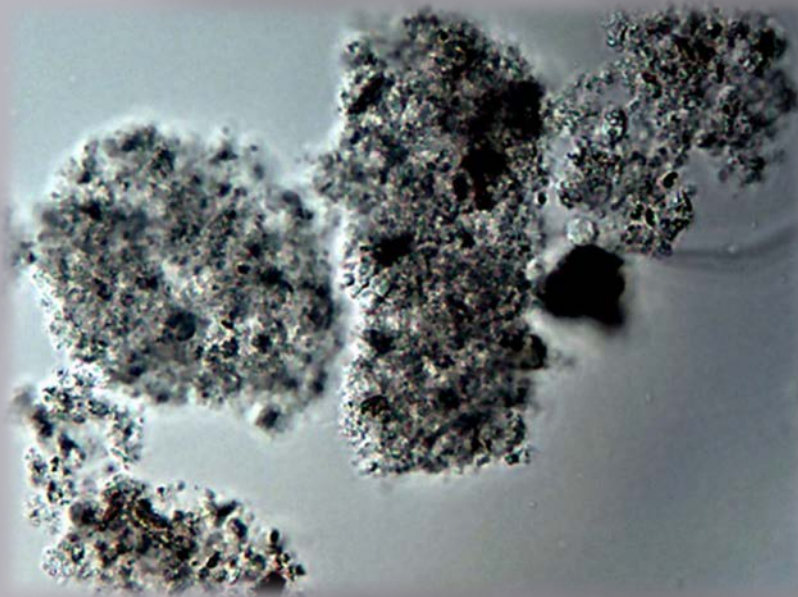
Some black spots due to septicity

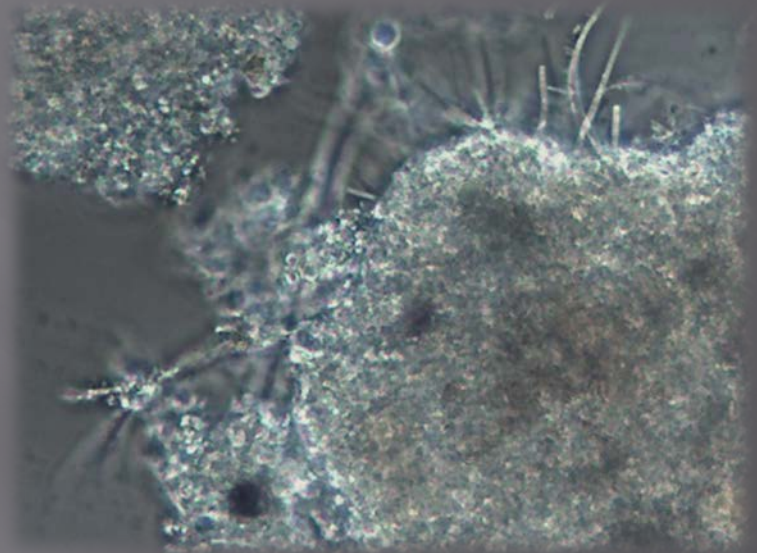
Only a few filaments

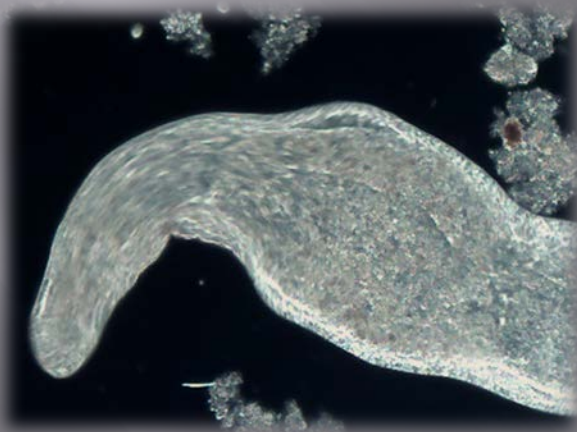
Worm

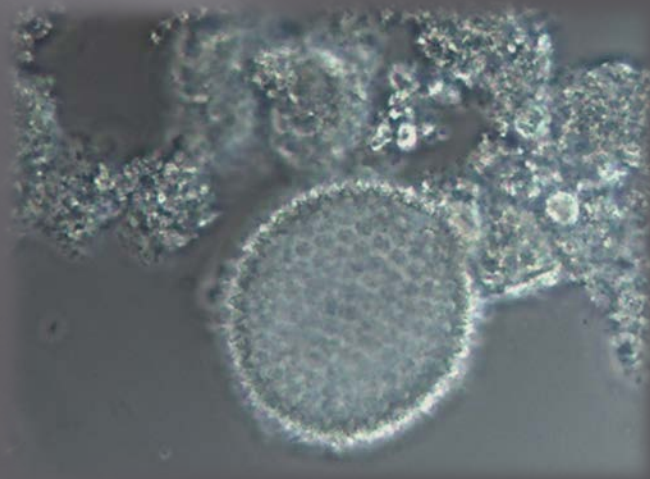
Pollen

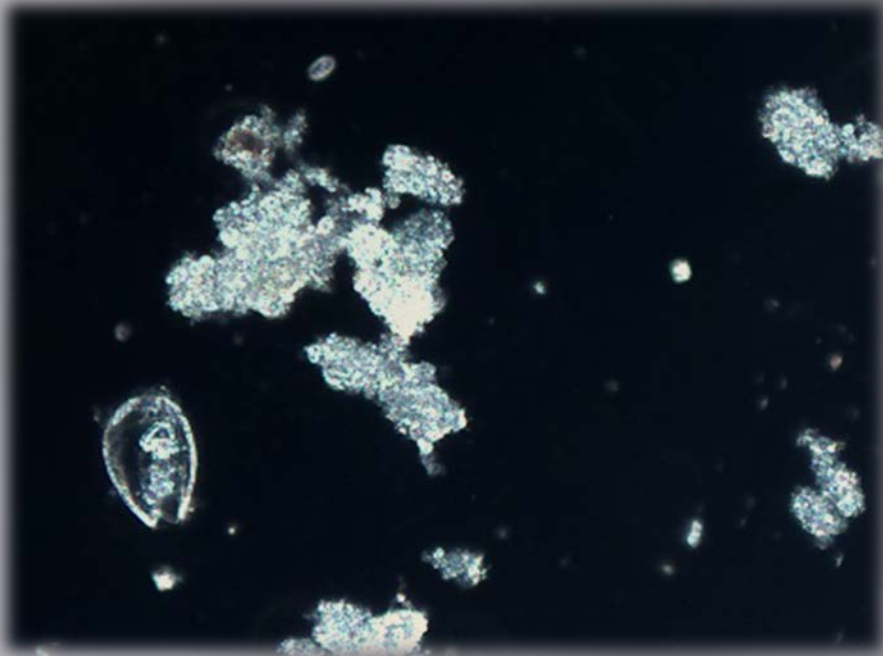
A little bit of fiber, check screening

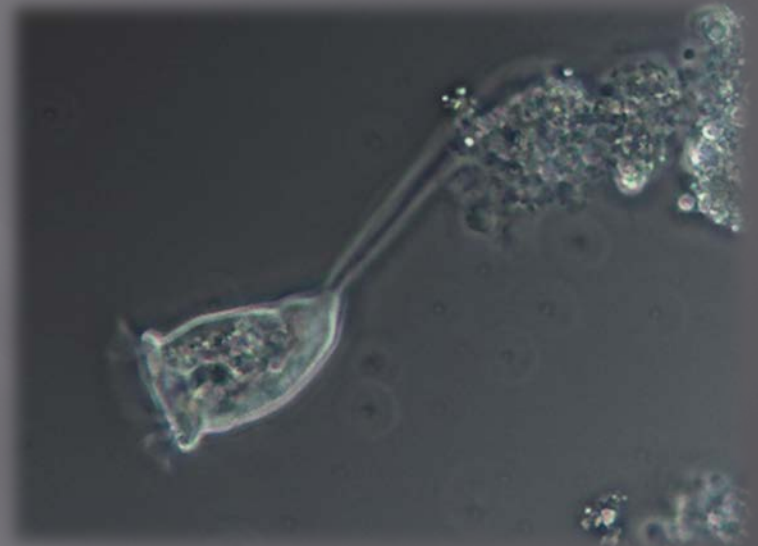
Stalked ciliates

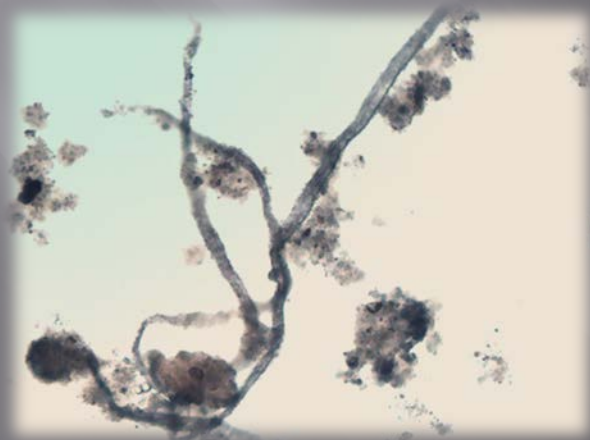
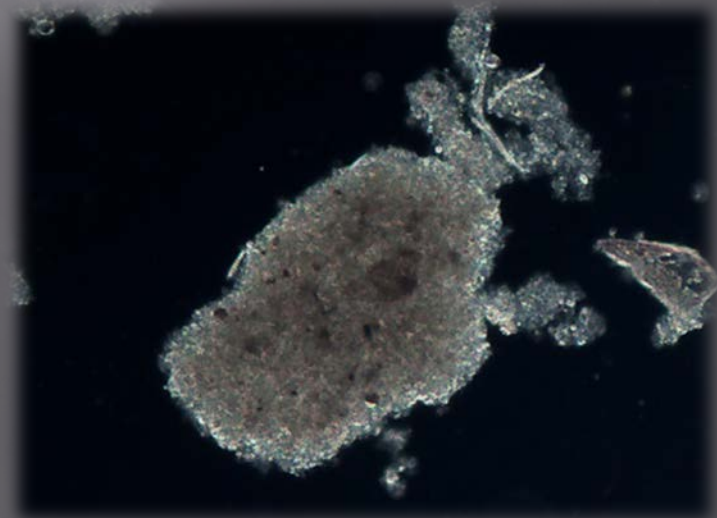
Nice firm, compact floc, clear supernatant
